Octane Cars

Baur wow wow!

**1981 BMW 323i
TOP CABRIO**
SANJAY SEETANAIAH

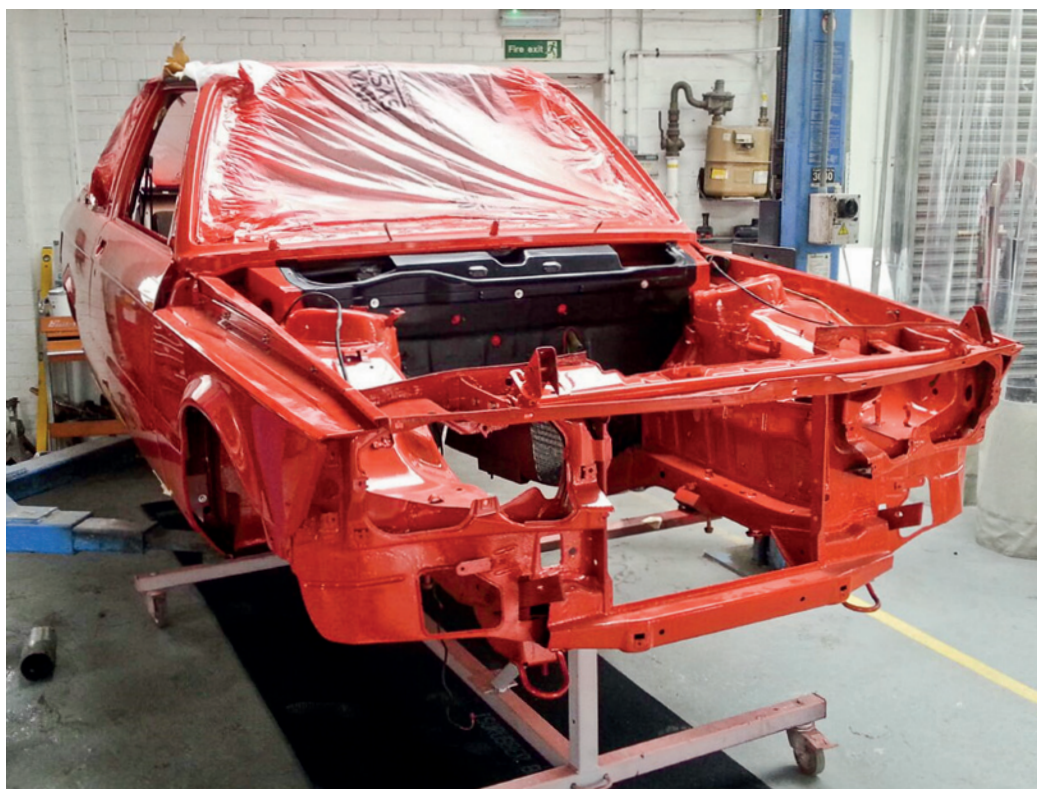
Clockwise from above
Refinished underside gains new heat shielding; bodyshell looks like new in shiny red, with all rust surgically removed; engine needed just a check and a clean.

AFTER EIGHT months in the workshop, completion of the Baur's restoration may be in sight. But getting to this stage has seen the job list get ever longer. The engine needed nothing beyond a good clean, but further inspection of the bodyshell revealed more rust, this time around the front floors where they join the sills, the jacking points and the rear subframe's mounting points.

So we had the discussion. Now we have started, was there any point in stopping the paintwork at just the exterior, the engine bay and the boot? So the suspension, exhaust, fuel pipes, brake pipes and fuel tanks were all stripped from the BMW, and the whole of the underside metalwork has been blasted and repainted.
